Accelerated Corrosion of Copper-Nickel Piping

NMAB-343

NATIONAL MATERIALS ADVISORY BOARD

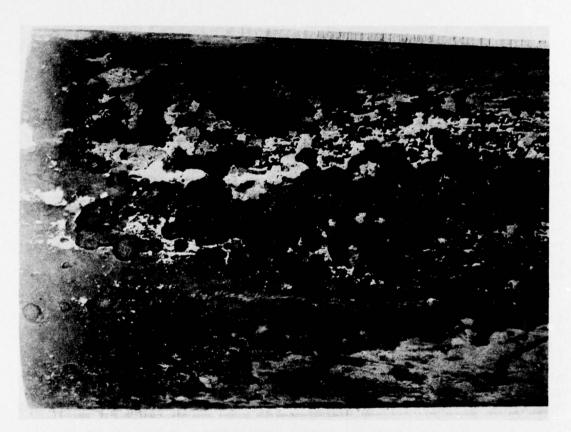
Analysis of the corrosion problem was conducted over a period of some three years at the David W. Taylor Naval Ship Research and Development Center. Figure 1 is a photograph of the inside of a corroded pipe. The phenomenology of the deterioration is as follows:

- 1. The majority of the damage occurred downstream from M bronze fittings and elbows (containing around 6% Sn, 1.5% Pb, 4% Zn, 0.5% Ni, balance essentially copper). These fittings caused turbulent flow at the pitted locations. There were occasional examples of erosion or localized attack as far as 2 to 3 feet from the elbows and flanges. These occurrences were limited. Pitting rarely occurred upstream of elbows or flanges.

- 2. The appearance of the corrosion product film in the pitted region was quite different from the normal dark brown adherent cuprous oxide coating that forms on CDA*706 (90/10 copper-nickel) in clean seawater. Instead, the films in the sites of localized attack were black or brown and were accompanied by flaky films that exhibited green, black or sometimes red colors.

- 3. Corroded areas generally were deep and sharply scalloped and exhibited symmetrical features. Erosion of the downstream edges of the pits was sometimes observed.

FIGURE 1 Typical Appearance of Corroded Inside Surface of Cupro-Nickel Piping. (Courtesy of U.S. Naval Ship Research and Development Center.)
